PREPARED BY THE U. S. ARMY BOARD FOR AVIATION ACCIDENT RESEARCH, FORT RUCKER, ALABAMA

OV-1 ACCIDENT SUMMARY

1 July 1966 through 30 June 1967

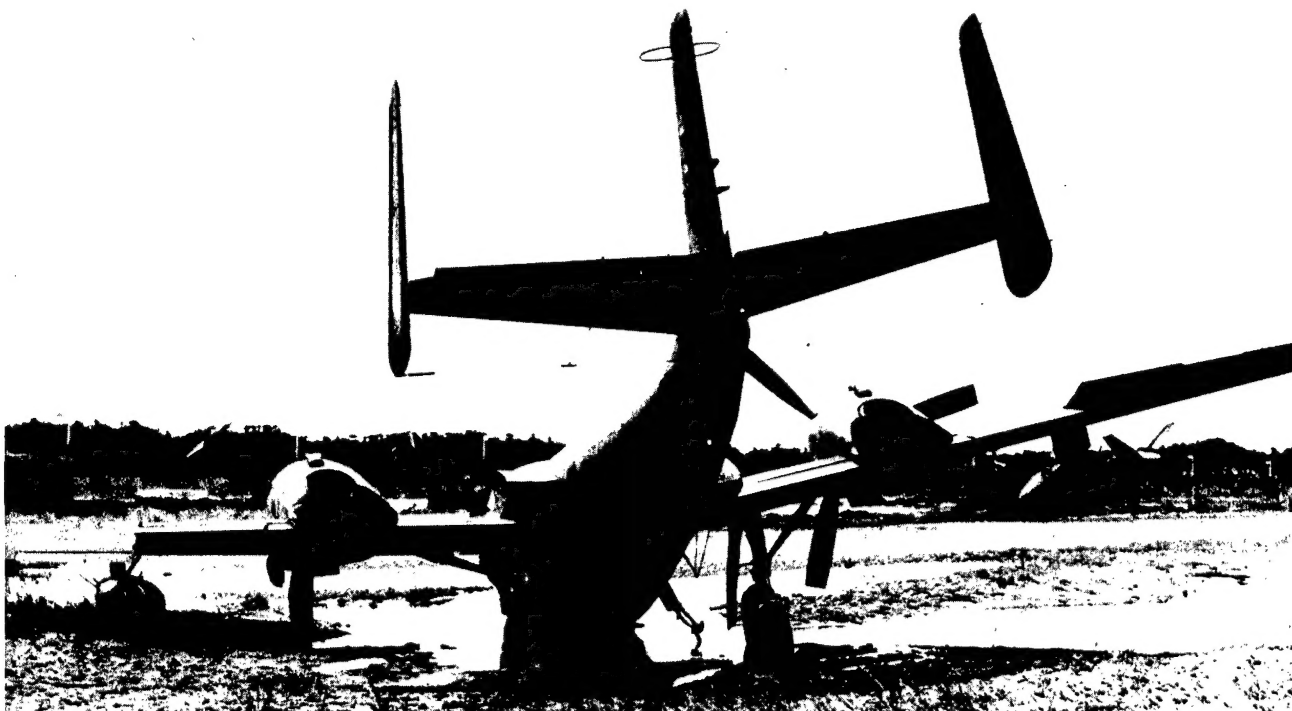
F495

F495—Odor was detected in cockpit and hydraulic pressure on both gauges dropped to zero. Flight was continued to burn off fuel in drop tanks, and approach was made, using emergency blowdown bottle to lower gear. Nose gear and right main gear locked, but left main gear failed. Right rudder was applied, and aircraft was yawed until left gear locked into place. A GCA, due to heavy rain and visibility, was made to a PSP, and two go-arounds were made before aircraft was aligned with PSP. Due to loss of hydraulic pressure, pilot had no power steering, power brakes, flaps, or windshield wipers. Landing light was turned off because of glare, and aircraft touched down about 1,000 feet down runway at 110 knots. Props were reversed and aircraft swerved left. Reverse power was reduced on No. 1 engine to idle reverse, and reverse power was pulled into No. 2 engine. Full right rudder, right aileron, and right brake were applied, but aircraft ran off runway, hitting rocks and sand. Nosewheel collapsed and aircraft slid on SLAR antenna. Full aft elevator was pulled and left main gear dropped into a concrete-lined hole, breaking gear, shoving it through wing and severing SLAR

antenna. Left prop struck ground and aircraft came to rest on left tip tank, nose, and right main gear. Both engines were shut down and attempts to feather were ineffective, because No. 1 propeller was striking the ground and No. 2 could not be pulled all the way in, due to lever catching on emergency gear blowdown handle. Caused by turning off battery switch before propeller could complete its travel while attempting to feather from reverse position, and failing to pull handle far enough or hold it long enough to completely lock the blowdown valve open and allow full available pressure. The bottle still contained 1,500 pounds of pressure and blowdown valve was in closed position. The hydraulic filters were dirty and the fluid was contaminated with debris and water. Two filters were not safetied and fluid starvation caused a vacuum in the pump. Small leaks were found throughout the system.

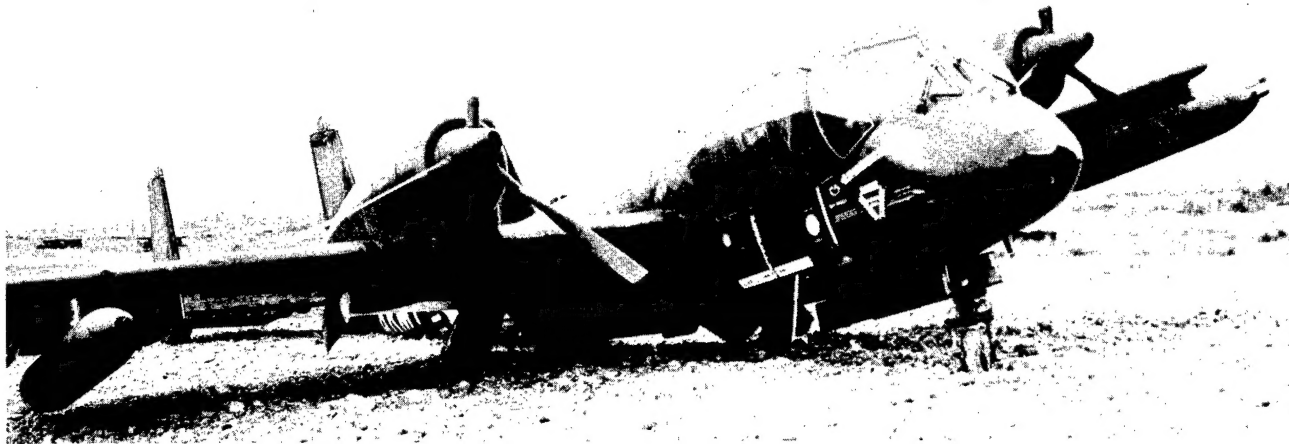
G922

G922—A VFR landing was attempted in poor visibility and heavy rain. GCA equipment was inoperative. Pilot made 360° turn 3 miles out on right base to let helicopter land. Forward visibility was zero and pilot lost sight of runway. Looking outside and using familiar ground references, pilot turned final. When runway was sighted, aircraft was off center and high. He made 180° turn and entered on left downwind for runway. Pilot told tower he was turning final with gear and pressure, and attempted to line up with runway by looking out the side. Tower would not clear aircraft for landing because of poor visibility. Pilot, thinking he had only 20 minutes of fuel left and that weather would get worse, continued on final. He sighted runway and thought he was at approach end, but he was actually about 1,800 feet out. Aircraft touched down with full flaps and swerved left, then skidded right before control was regained. Runway was 6,000 feet of PSP. Only 3,000 feet were available due to resurfacing. There was not enough room to go around. One piece of PSP was not interlocked with the adjoining piece, and protruded, causing all three gears to hang as aircraft crossed with brakes locked. Aircraft hit construction area and gear collapsed. Damage was so extensive that only the engines could be salvaged. Caused by attempting to remain VFR in IFR conditions. Other factors were weather, improperly installed PSP, and lack of overrun.
